The last time around, we covered the basics in getting the front suspension, steering and braking system back on our respective freshly powder coated chassis. As promised, let's move on to the chain drive, wheels and tires.

Chain drive and drive couplings:

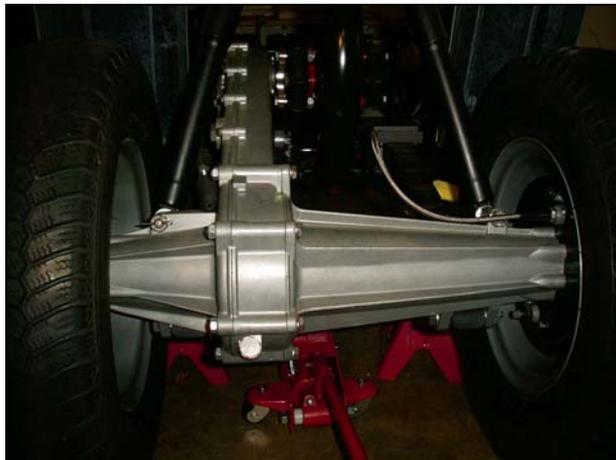
Nice new, shiny chain drive sporting new Michelins.

Both of our chain drive casings did time in Robert's bead blaster. Those glass beads really do a nice job on cast aluminum! The first pass makes it look great but the second pass really does the trick!

We both replaced the small bolts that hold on the grease seal retaining rings on both sides as well as the four that are used on the chain adjuster plate. Bead blasting the original case bolts turned them back into brand new condition although new nuts and spring washers replaced the originals. Robert went an extra step and put a really nice polished finish on his chain adjuster plate. Looks sharp!

Robert went with BF Goodrich Silvertown wide whitewalls and Bruce went with the Michelin MX 145R10 blackwalls. Then came the other running gun battle about bias ply vs. radials and the wider cross section on the Michelins. First, Bruce's car isn't being built for a show judge's sake so the "minus points" issue was moot. He also wanted a nice, aggressive tread in case he ever got involved in a high speed chase and needed a surefire edge in outmaneuvering those Crown Vic Police Interceptors. Second, bias ply tubes (the only type of 10" bent stem tubes available from Coker, or anyone else for that matter) in radial tires that are going to spend their lives mounted on a 13 horsepower, 30-45 mile per hour, one-lung-hemi racing machine is hardly an issue. Coker Tire blessed the application under those circumstances. Robert wanted to keep his car as close to spec as he could, liked the whitewall look and explained that he would simply use his great line of bull to talk his way out of a ticket rather than take Bruce's tactical approach.
